Report of Turnover Study

**RICHMOND PARK MASTER CONDOMINIUM
ASSOCIATION**

**2305 Richmond Park Lane,
Naples, Collier County, Florida**

**SOCOTEC Project Number 6690-001.01
July 2022**

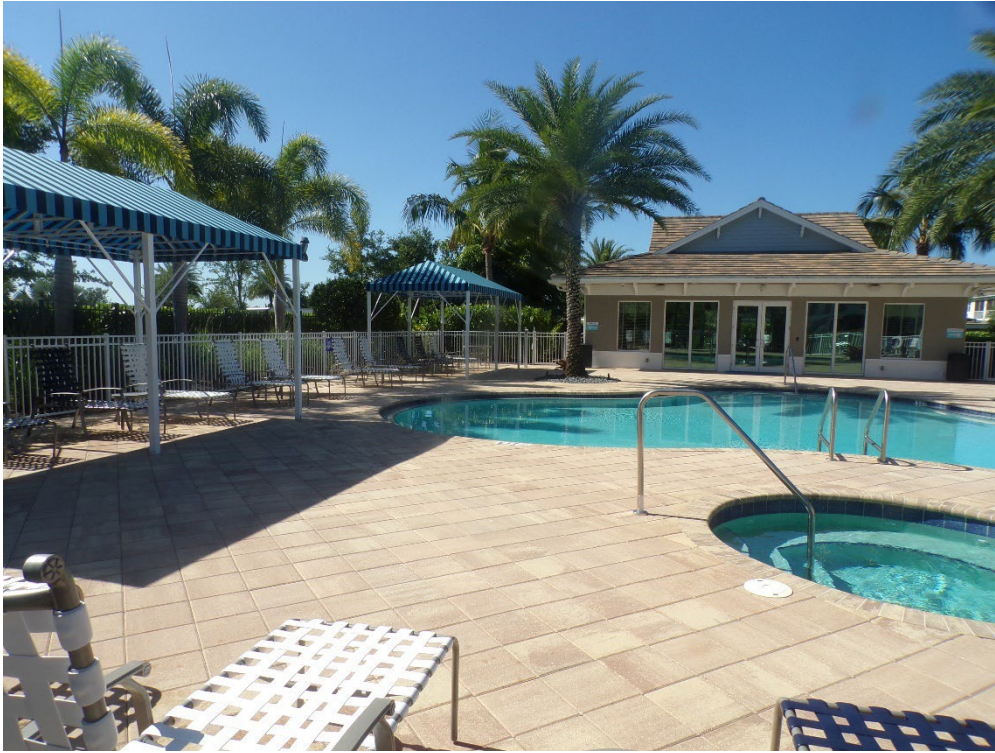
Overall view of Clubhouse.

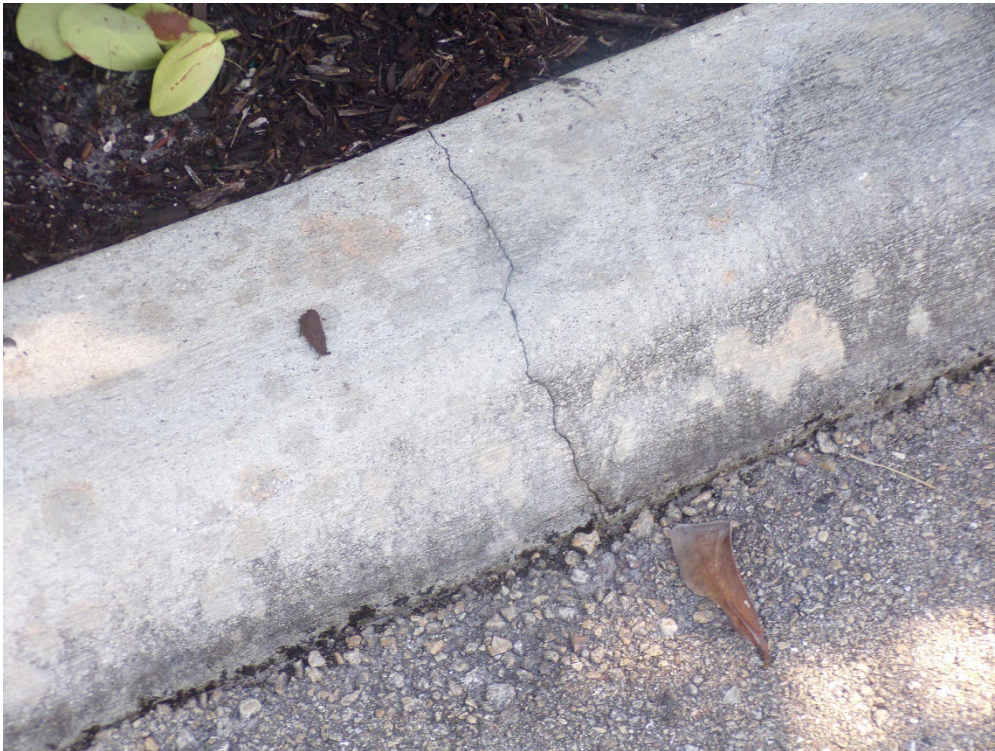
- Various concrete cracks throughout the concrete curbs and concrete valley gutters.
- Painted lines for common area parking spaces are beginning to fade.

View of typical concrete curb crack.

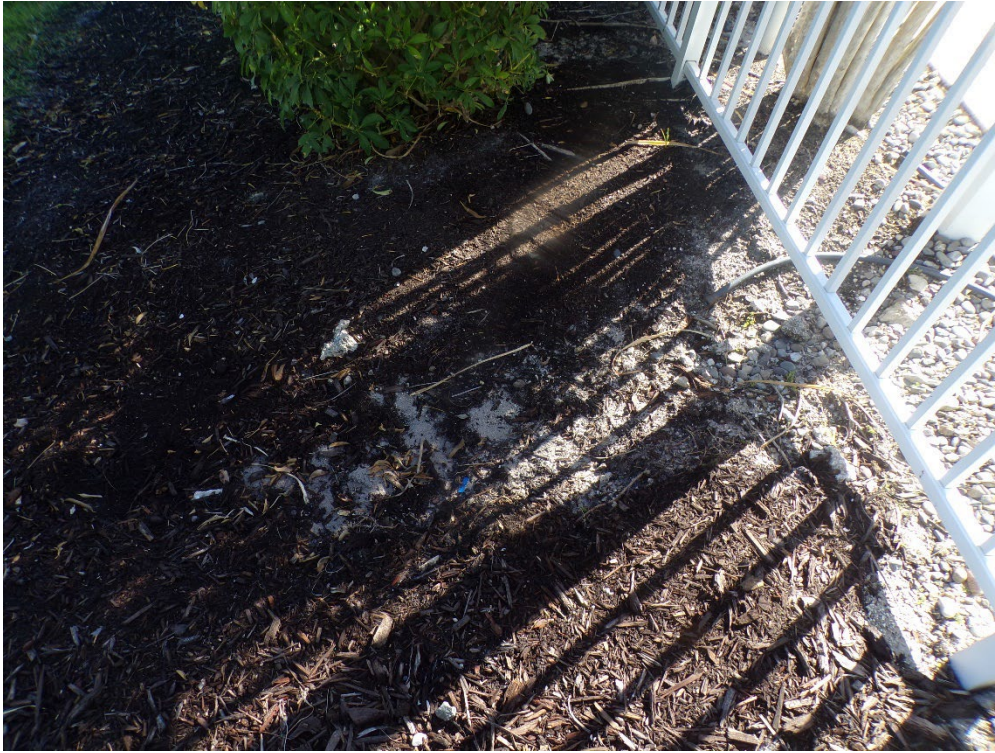
- Instances of mulch washout around several buildings, including the clubhouse.
- Three instances of missing pink-flowering trees, and one dying tree (appear to be crepe myrtle trees).
- Several instances of non-camouflaged pipes by the pond fountain (no surrounding foliage).
- Inconsistent shrubbery around guest parking areas on Sawyers Hill Road.

View of minor soil washout next to pool area.

Address cracked/damaged stucco		\$1,000			
Address paint smears and sloppy paintwork		Minimum			
PERIMETER FENCE AND GATE	Good to Fair	\$6,500	30+	28+	NA
Address missing section of perimeter fence		\$6,500			
IRRIGATION & LANDSCAPING	Fair	\$32,500	Irrigation Lines 30+ Sprinklers 5 - 15	28+ 3-13+	NA
Address missing pink-flowering trees between buildings 2303, 2311, and 2295 (3 missing)		\$1,500			
Address dying pink-flowering tree between buildings 2303 and 2295		Minimum			
Address non-camouflaged pipes between buildings 2319 and 2311, and Priory Lane/Sawyers Hill Corner		Minimum			
Address inconsistent Shrubbery around guest parking areas on Sawyers Hill Road		\$1,000			
Address laurel oak trees planted around the association. Remove and replant with suitable trees (19 trees)		\$28,500			
Address mulch washout around various buildings, including clubhouse.		Minimum			
ELEMENT TOTAL		\$47,000

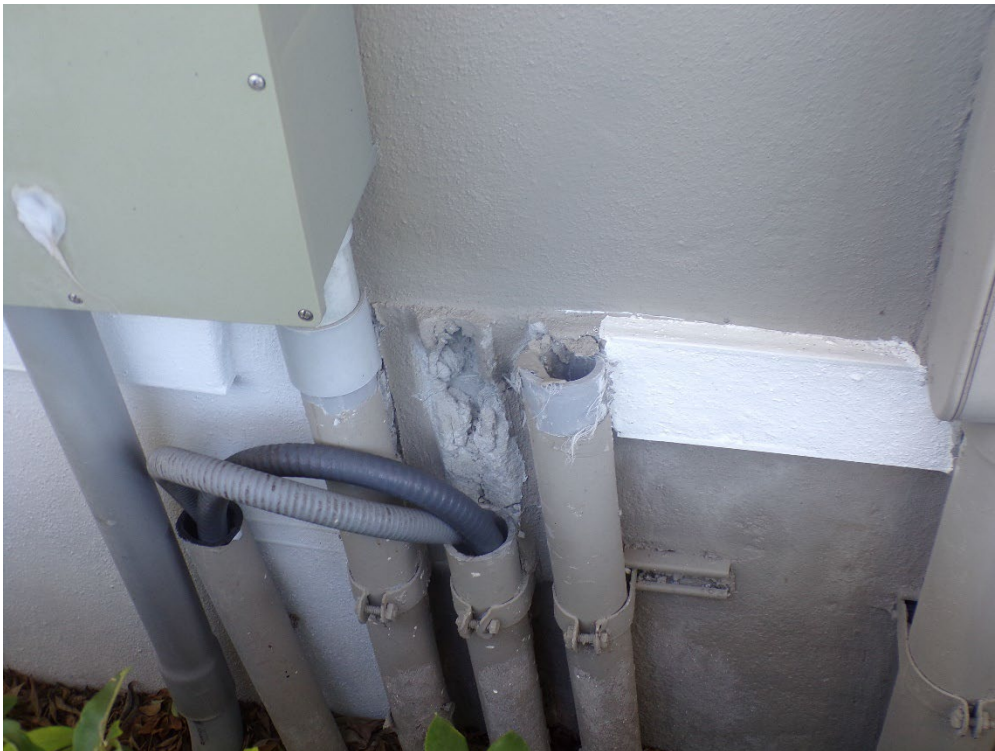
Unsealed electrical and poorly finished stucco.

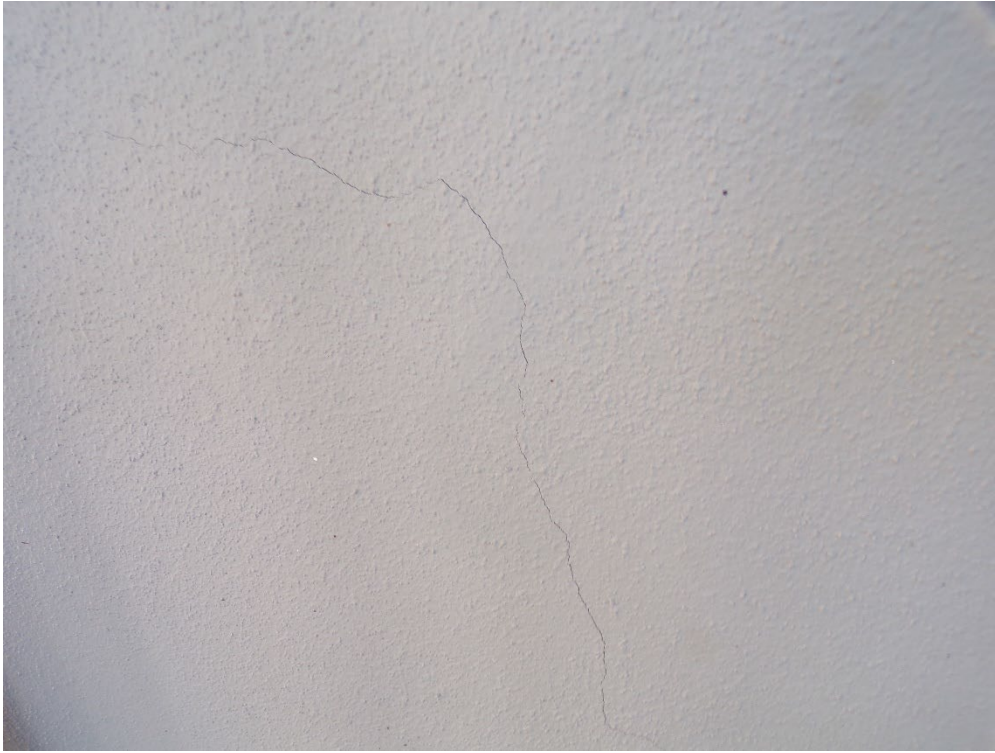
- Cracked and/or damaged stucco around various areas of the building.
- Paint smears on downspouts, and sloppy paint work around the various building corners.

View of typical stucco crack on side of clubhouse.

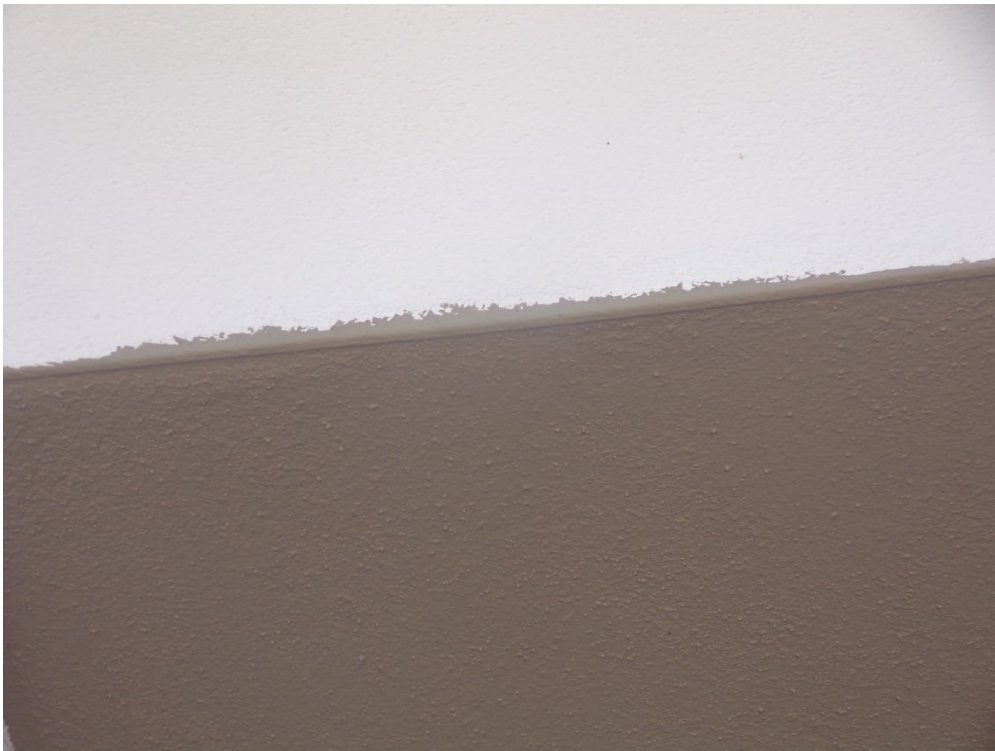
View of sloppy paint job on clubhouse edge.

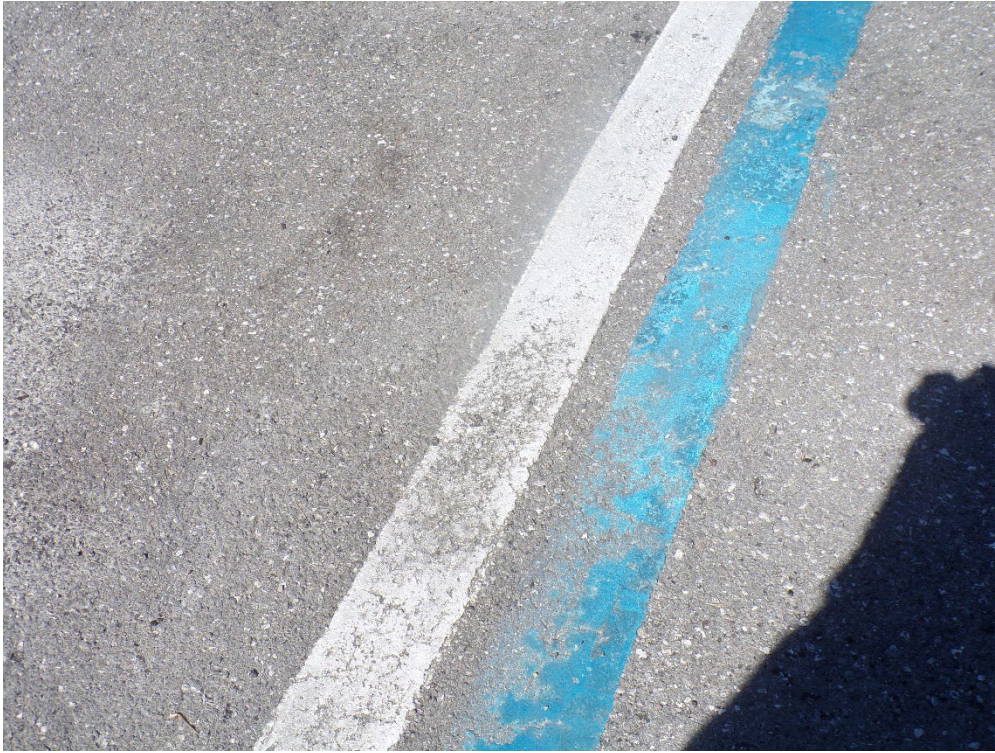
View of fading paint stripes on parking spaces.

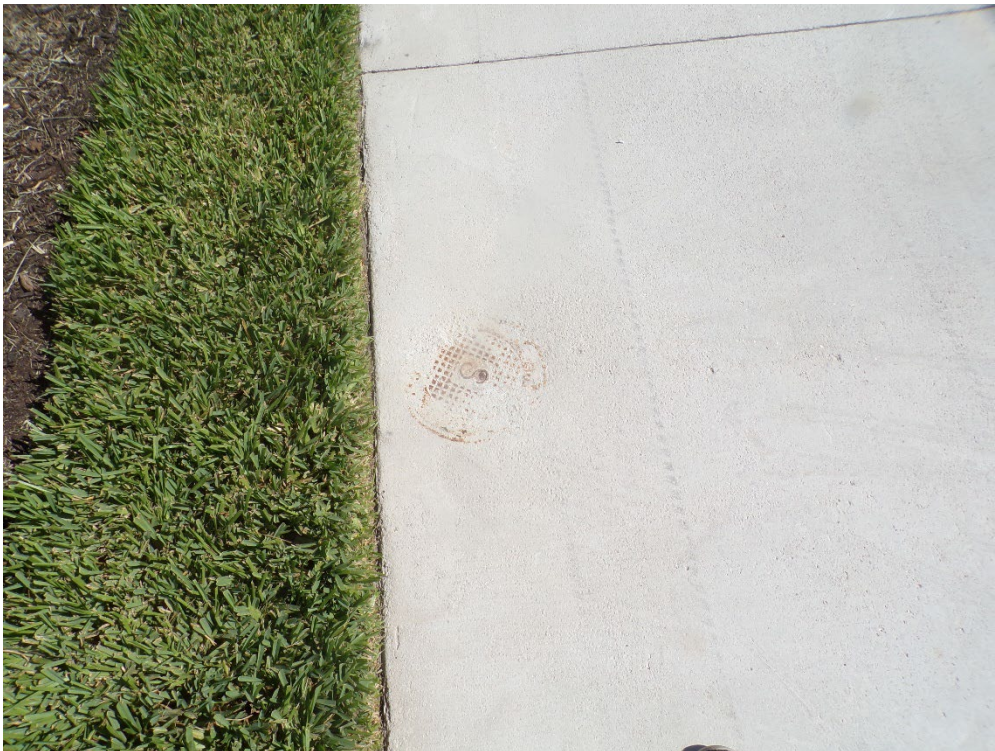
- Several sewer line covers have been obstructed with concrete from when the sidewalk was poured.

View of inaccessible drain cover.

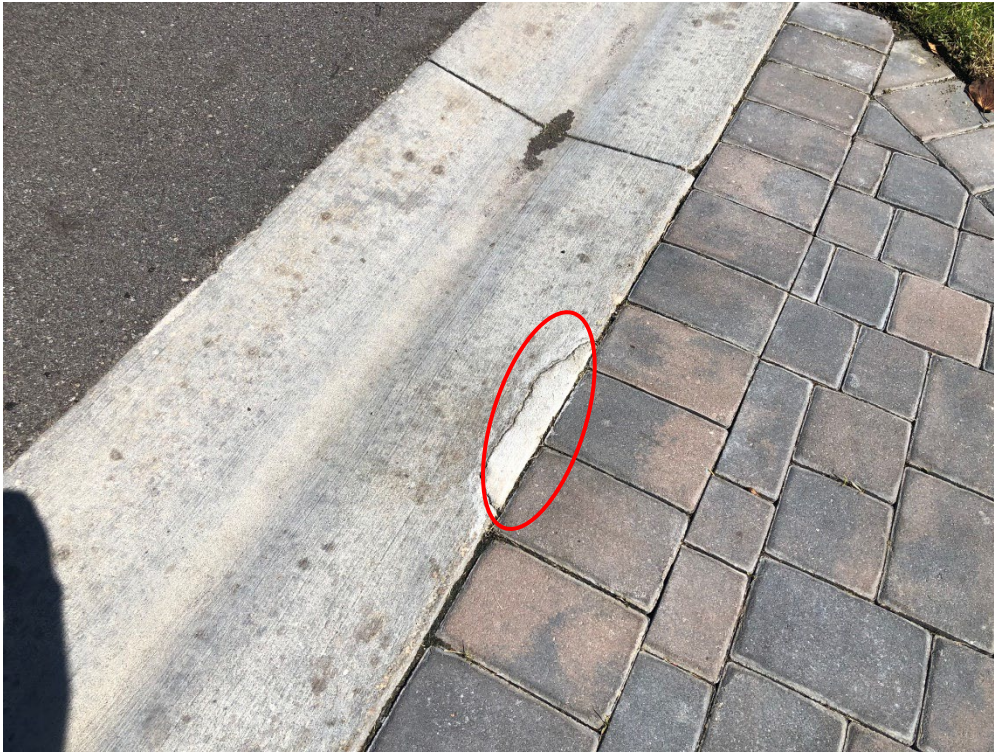
View of crack on concrete valley gutter.

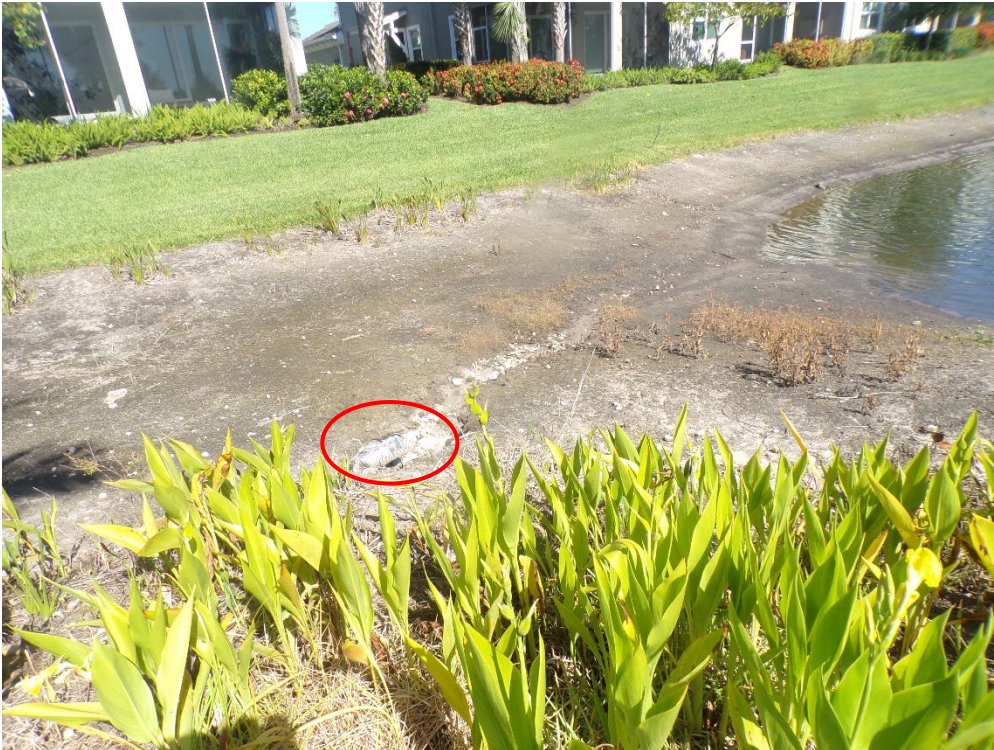
View of exposed pipe.
