TURNOVER STUDY REPORT

Richmond Park Master
Richmond Park Lane
Naples, Collier County, Florida
Velocity Project Number: 21-447

Date: August 12, 2022

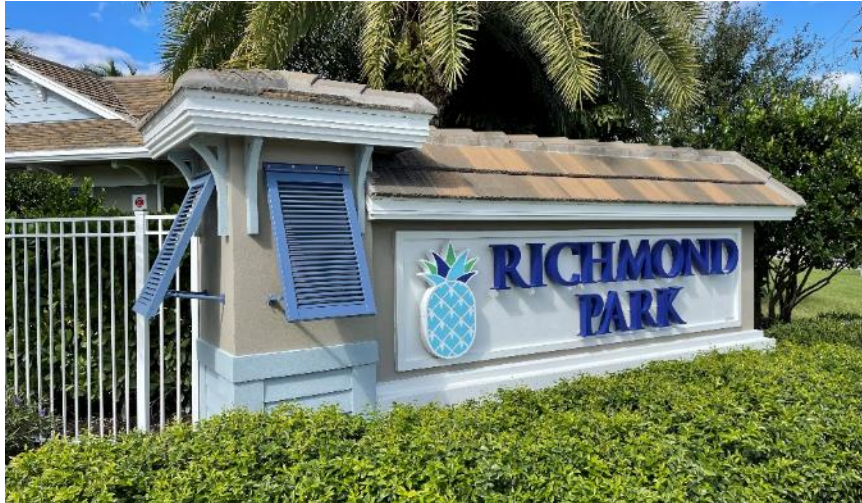
The entrance into the community includes 2 entry monuments. The monuments appear to consist of concrete masonry unit (CMU) construction with a stucco finish and concrete tile. The monuments were constructed in 2017 and appears to be in good condition.

Photo 2.1.1-1: General view of entry monument

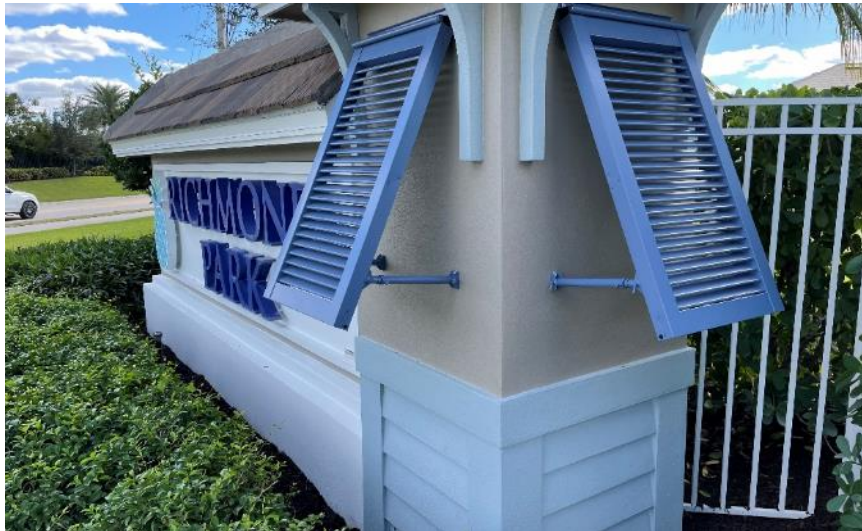
Photo 2.1.1-2: General view of entry monument

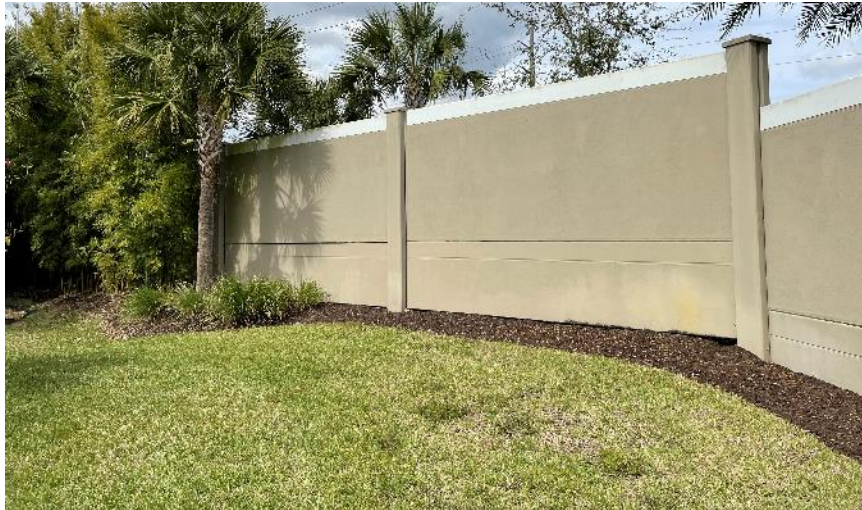
An 8 to 12-foot-tall precast concrete perimeter wall is located along the northern property line of the community (along Immokalee Road) and along a small portion of the east property line (Woodcrest Drive). The concrete wall was installed in approximately 2017 and was in good overall condition at the time of Velocity's inspection.

Photo 2.1.2-1: Typical section of perimeter wall

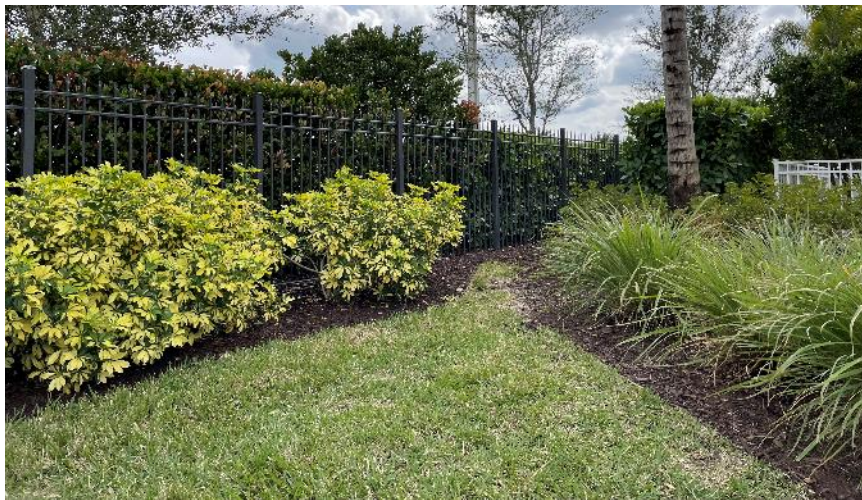
A 6-foot-tall aluminum perimeter fence is located along the east property line of the community (along Woodcrest Drive) and at the entrance into the community. A 4-foot-tall aluminum fence is located around the pool deck. It is understood that the aluminum fencing was installed in approximately 2017. The aluminum fencing was in good overall condition at the time of Velocity's inspection.

Photo 2.1.2-2: Typical section of perimeter fence

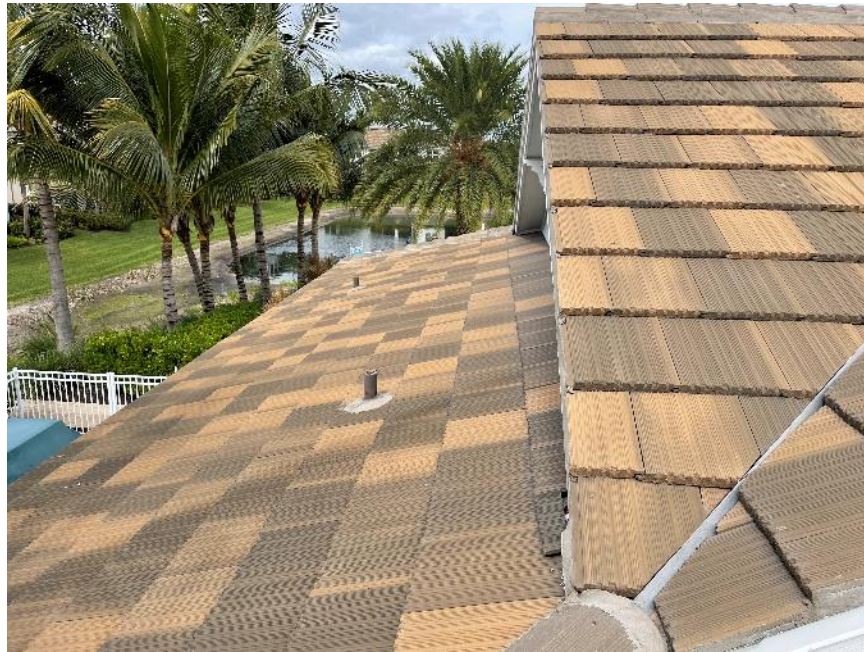
Photo 2.3.2-1: General view of clubhouse roof

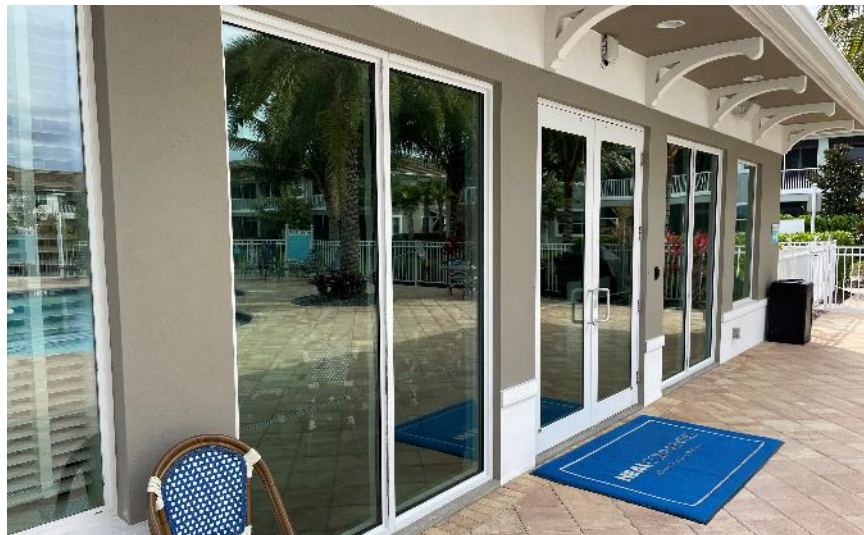
Windows and doors at the clubhouse appeared to be adequately sealed.

Photo 2.3.3-1: Windows and doors appeared to be properly caulked

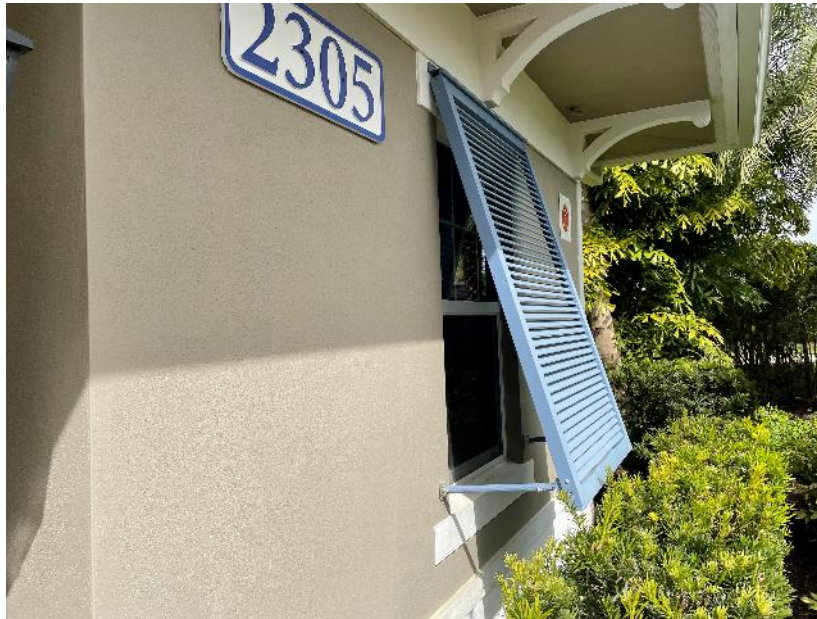
The exterior of the clubhouse was painted in approximately 2017. The clubhouse's paint appears to be in good overall condition.

Photo 2.3.4-1: Typical clubhouse exterior paint condition

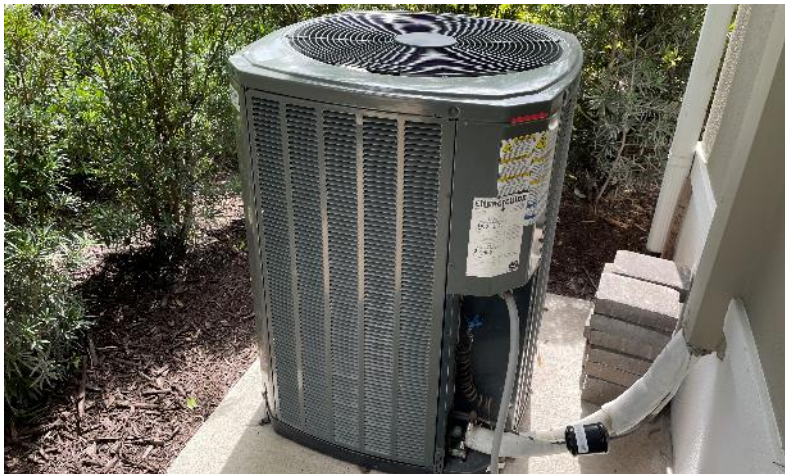
The HVAC system at the clubhouse consists of a Trane 5-ton split system air conditioning. The HVAC system appeared to be in good condition and was functioning properly at the time of Velocity’s inspection.

Photo 2.3.5-1: Air conditioning condensor at clubhouse

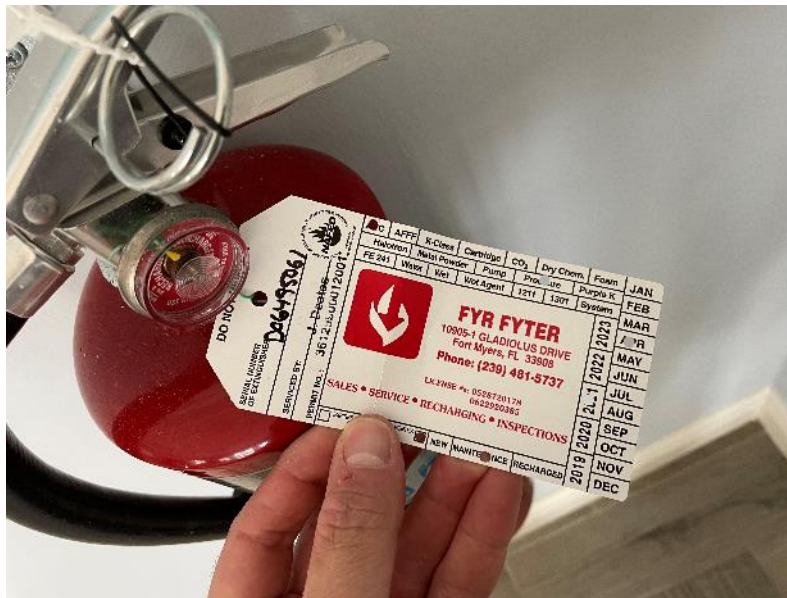
The clubhouse does not utilize a fire protection system. However, fire extinguishers were observed within the clubhouse. Current inspection tags were observed on fire extinguishers.

Photo 2.3.6-1: Current inspection tag on fire extinguisher

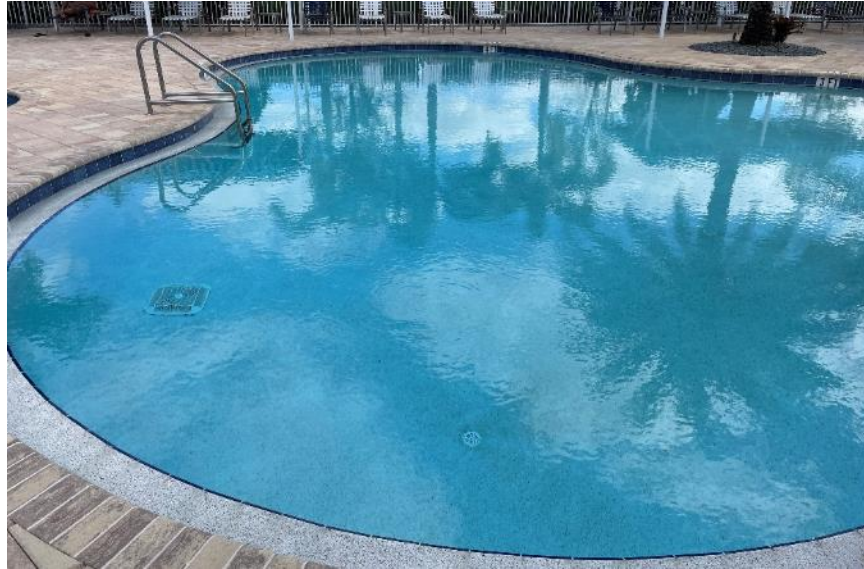
The swimming pool was constructed in 2017 and appeared to be in good overall condition at the time of Velocity's inspection. No cracking or discoloring in the pool shell finish was observed at the time of Velocity's inspections.

Photo 2.4.1-1: Swimming pool

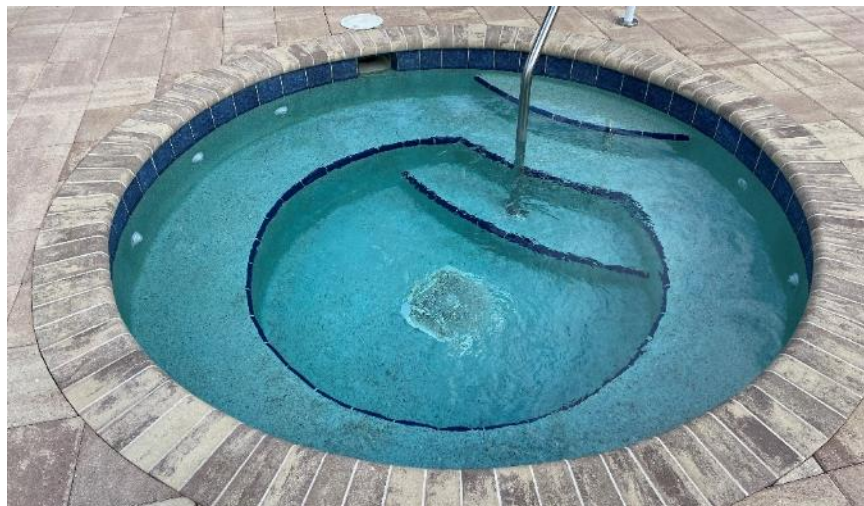
The spa was constructed in 2017 and appeared to be in good overall condition at the time of Velocity's inspection. No cracking or discoloring in the spa shell finish was observed at the time of Velocity's inspections.

Photo 2.4.2-1: Spa

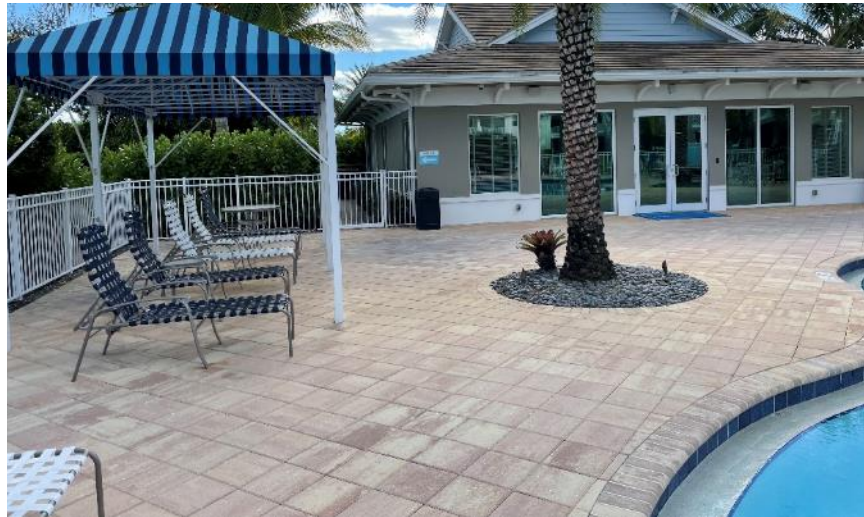
The pool deck consists of concrete pavers and associated planters that were installed in approximately 2017. At the time of Velocity's inspection, the pool deck was in good overall condition.

Photo 2.4.3-1: Pool deck

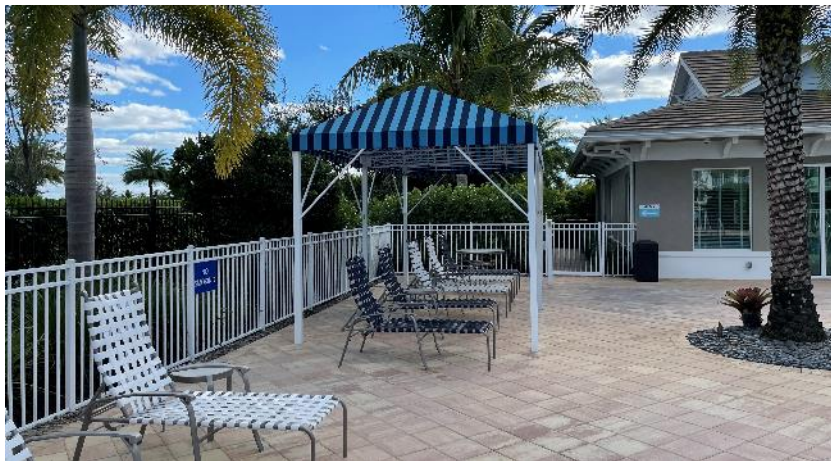
There is a 4-foot-tall aluminum picket fence surrounding the pool deck. The aluminum fence appeared to be in good overall condition at the time of Velocity's inspection.

Photo 2.4.5-1: 4-foot-tall aluminum picket fence

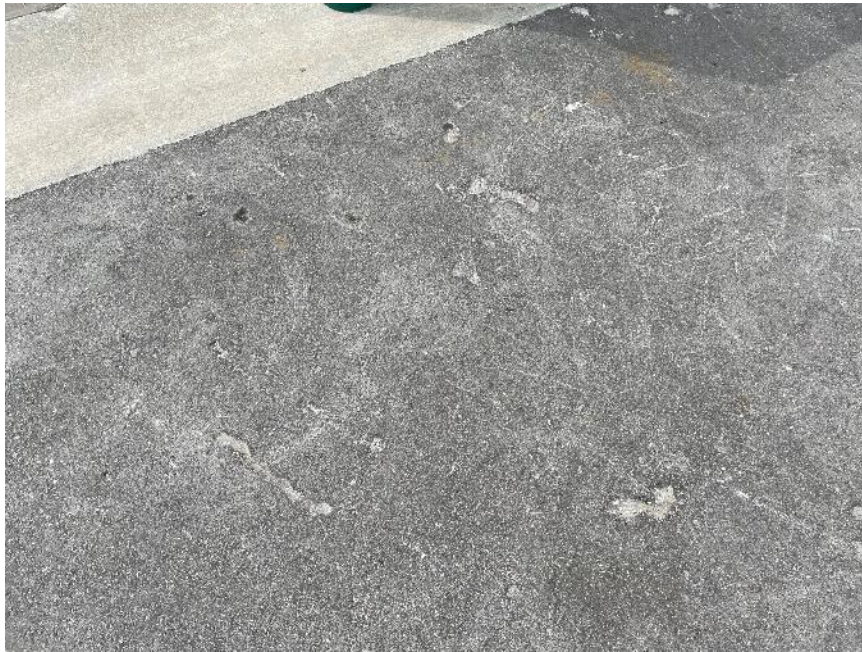
The asphalt pavement was in good overall condition at the time of Velocity's inspection. Velocity observed isolated surface damage and staining along Sawyers Hill Road.

Photo 2.5.1-2: Surface damage at Sawyers Hill Road

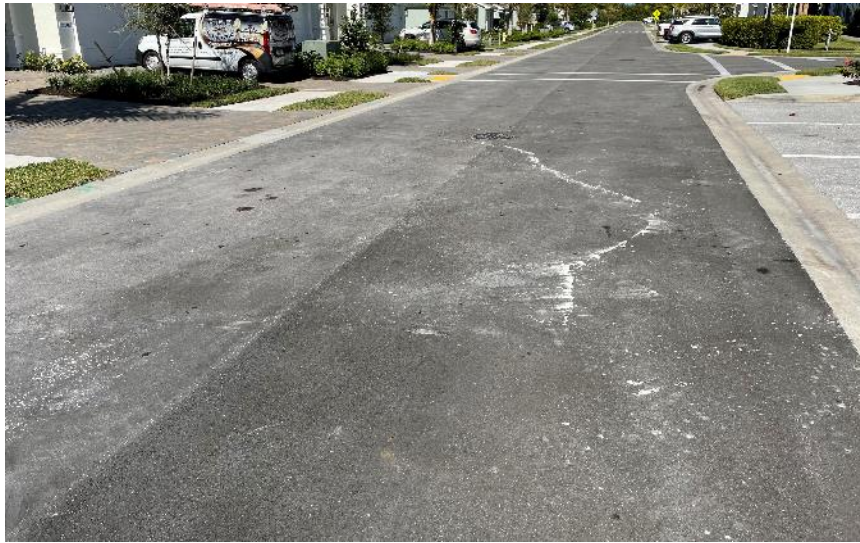
Photo 2.5.1-3: Surface staining at Sawyers Hill Road

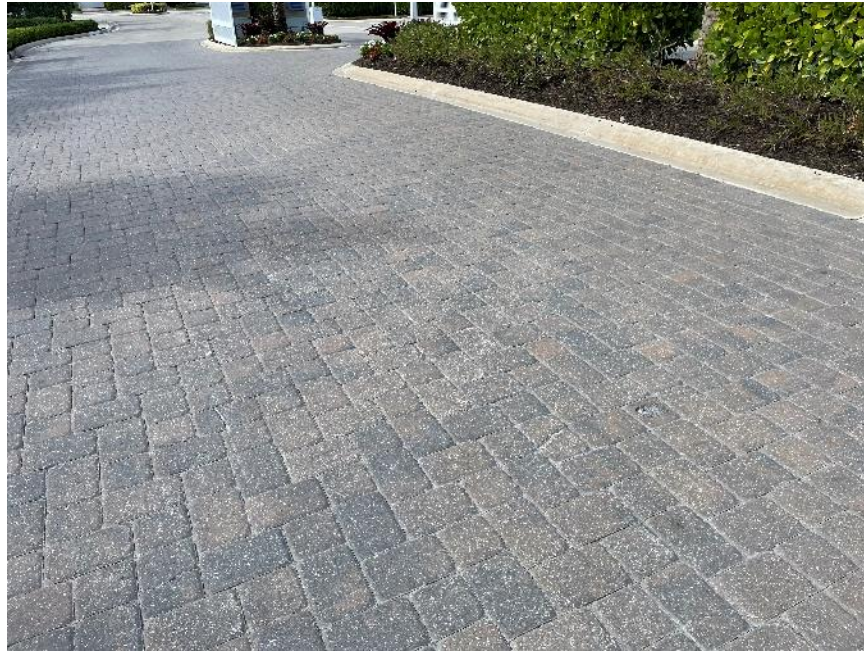
There are roadway pavers located at the entrance to the community. The pavers were in good overall condition at the time of Velocity's inspection.

Photo 2.5.2-1: General condition of pavers at entrance

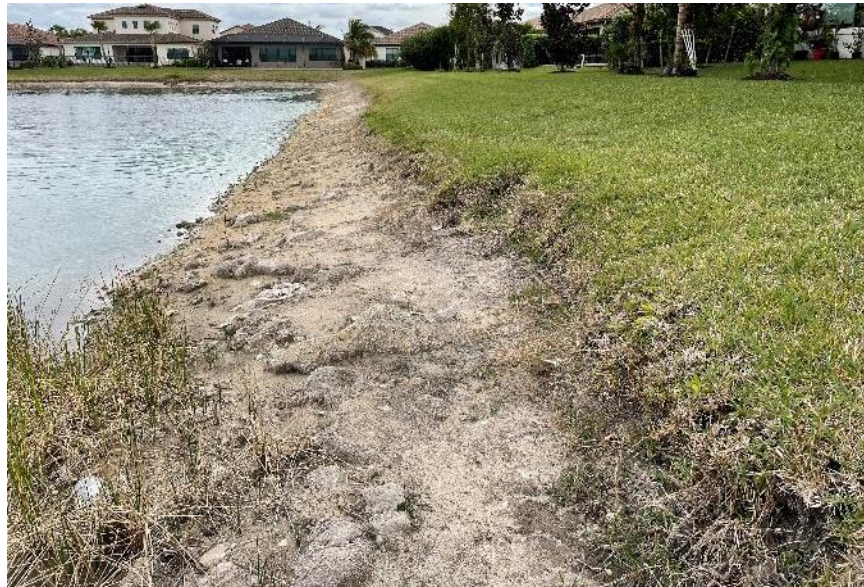
Velocity observed isolated instances of lake bank escarpment/erosion occurring at the south and west sides of Lake 2B. In addition, Velocity observed plastic drainage structures directly adjacent to the erosion on the south end which are likely connected to the gutter downspouts of the adjacent houses within the Bent Creek community. These drainage structures may be contributing to the observed erosion.

Photo 2.7-4: Isolated erosion at west side of Lake 2B

It is understood that the restoration and stabilization of the lake banks is planned once the wet season ends and the water levels within the lake drop.

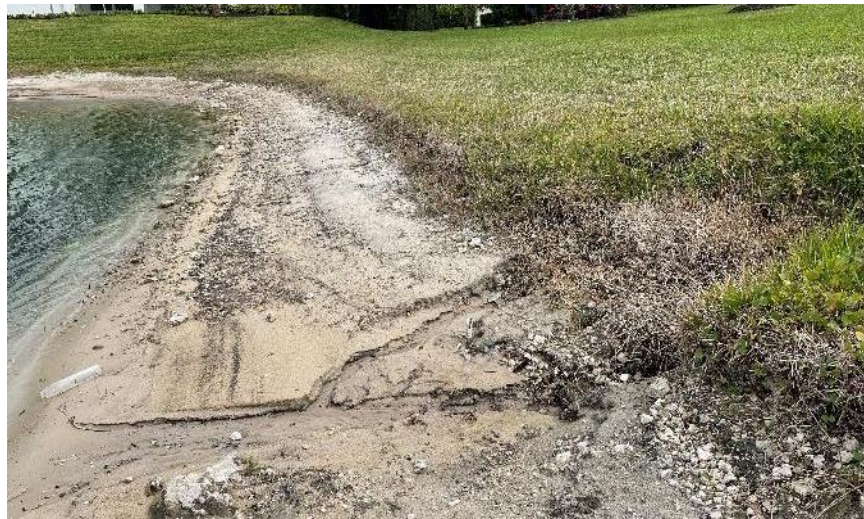
Photo 2.7-5: Isolated erosion at south side of Lake 2B

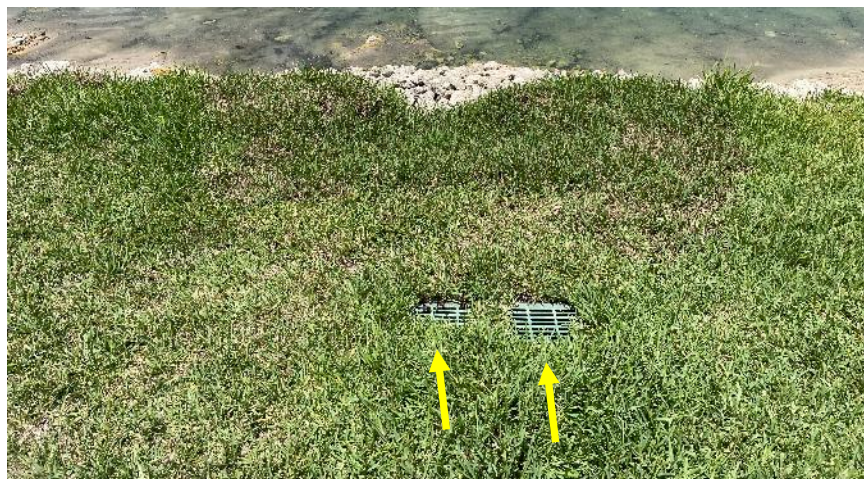
Photo 2.7-6: Drainage structures adjacent to erosion at south side of Lake 2B
